TREE SURVEYS

PREPARED BY:
HORTSCIENCE

TREE CENSUS SUMMARY
Sunnyvale Industrial-to-Residential
(ITR) Project Site
Sunnyvale CA

April 2006

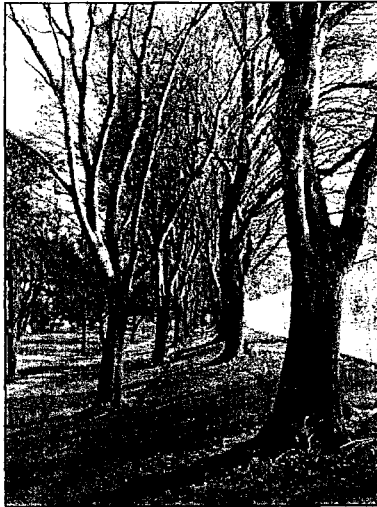
Photo 1. Double row of evergreen ash along Duane Ave.

Evergreen ashes were located in two areas: as a double row along the Duane Avenue frontage (photo 1) and as street trees adjacent to a service road and parking area. Trees were mature in development with trunk diameters from 16" to 40". All of the ash trees met the City of Sunnyvale's criteria for Protected status. Overall condition of ash trees was good; none were in poor condition. The form was typical of the species: a vase-shaped crown formed by several scaffold limbs that arose at one point on the trunk and extensive surface roots. A number of ashes had long lateral branches. Several had a history of branch failure.

- Retaining trees in groups such as the evergreen ash plantings along Duane Avenue and near the AMD parking lot, as well as the groups of coast redwoods in the turf area.
- Limiting damage to surface roots of evergreen ash by holding excavation 10' from the tree trunks.
- Providing supplemental irrigation during the demolition and construction phases.

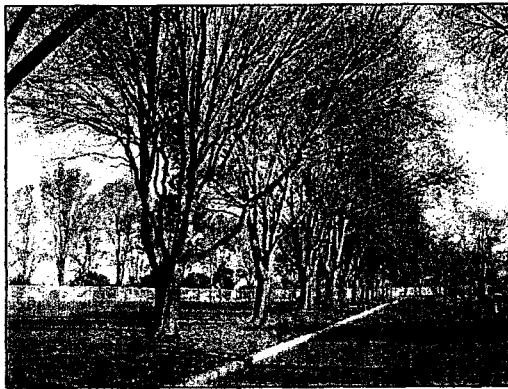
Photo 2. Single row of ash along interior street.

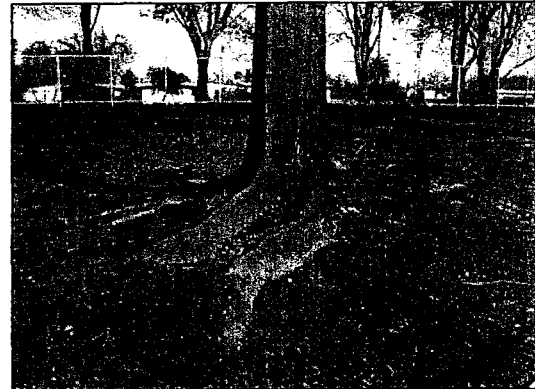
Photo 3. Many ash had large surface roots.

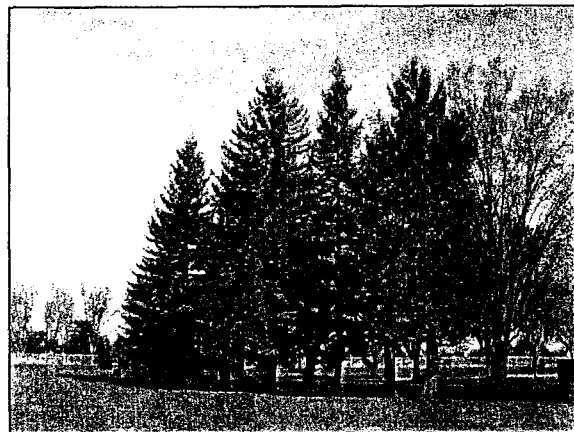
Coast redwoods were a mix of semi-mature and mature in development; all but one were greater than 12" in diameter. Most redwoods were in excellent condition with well-developed crowns (photo 4).

Photo 4. Grove of coast redwoods.
